Voyager®

Department of Transportation
**FEDERAL MOTOR VEHICLE
SAFETY STANDARDS**

FMVSS No. 111

ASA Electronics FMVSS No. 111 Testing Environment

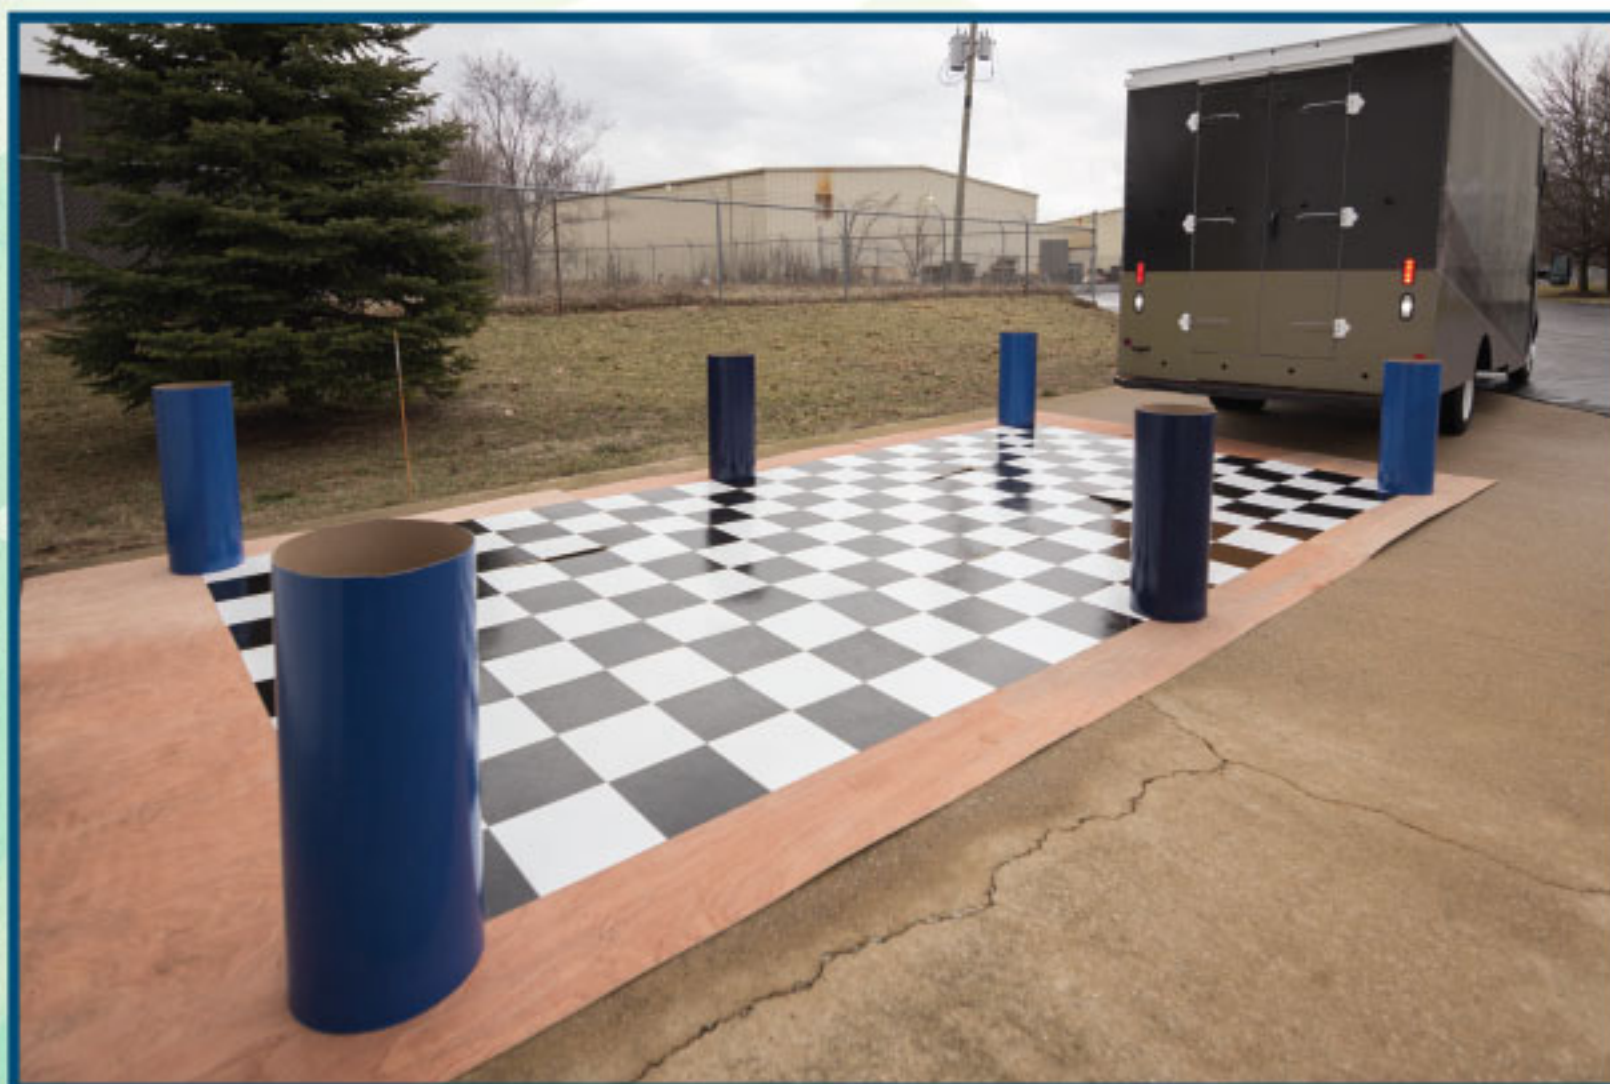
"The K.T. Safety Act" FMVSS No. 111 mandates a field of view test. This test includes "a cylindrical test object with a height of 32 inches and a diameter of 12 inches, consistent with an 18-month-old toddler."

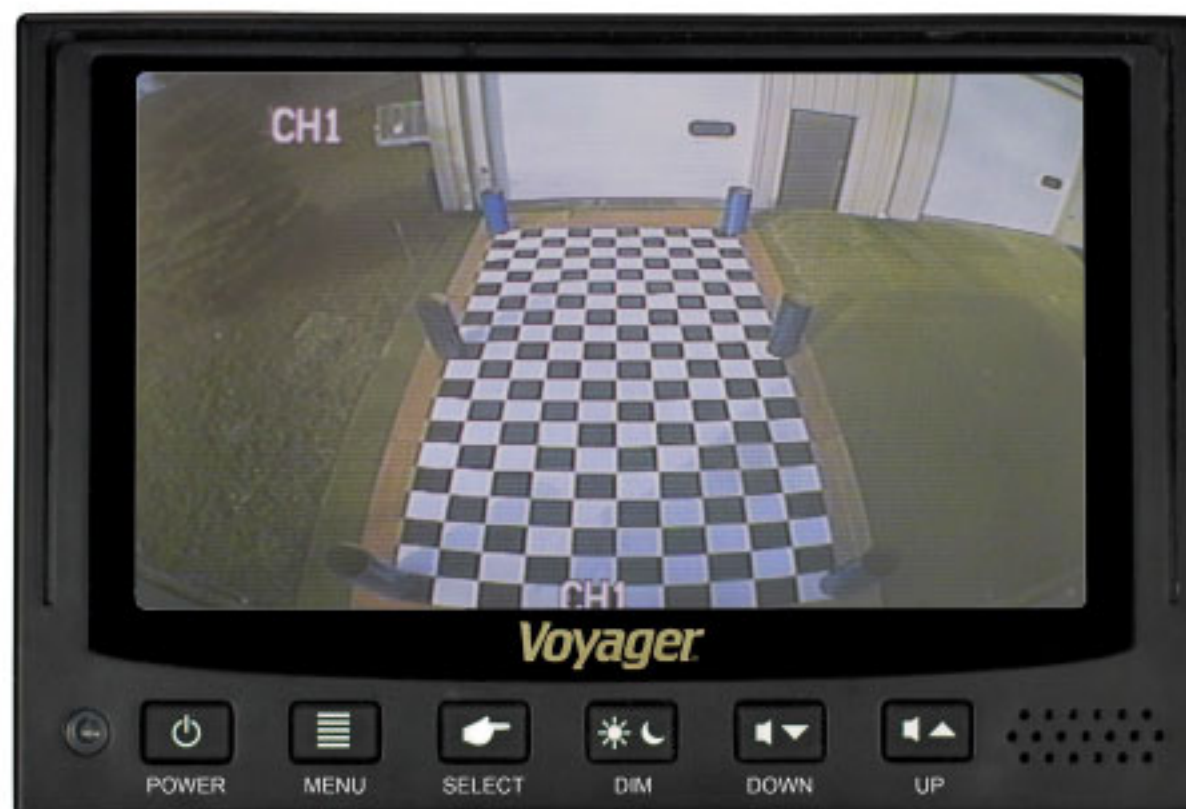
Vehicle Type: Box Truck
Camera Height: 12.5'
Camera Used: VCMS155

Extended Side View Measurements

- 9.6' from first markers
- 16.0' from second markers
- 23.8' from third markers

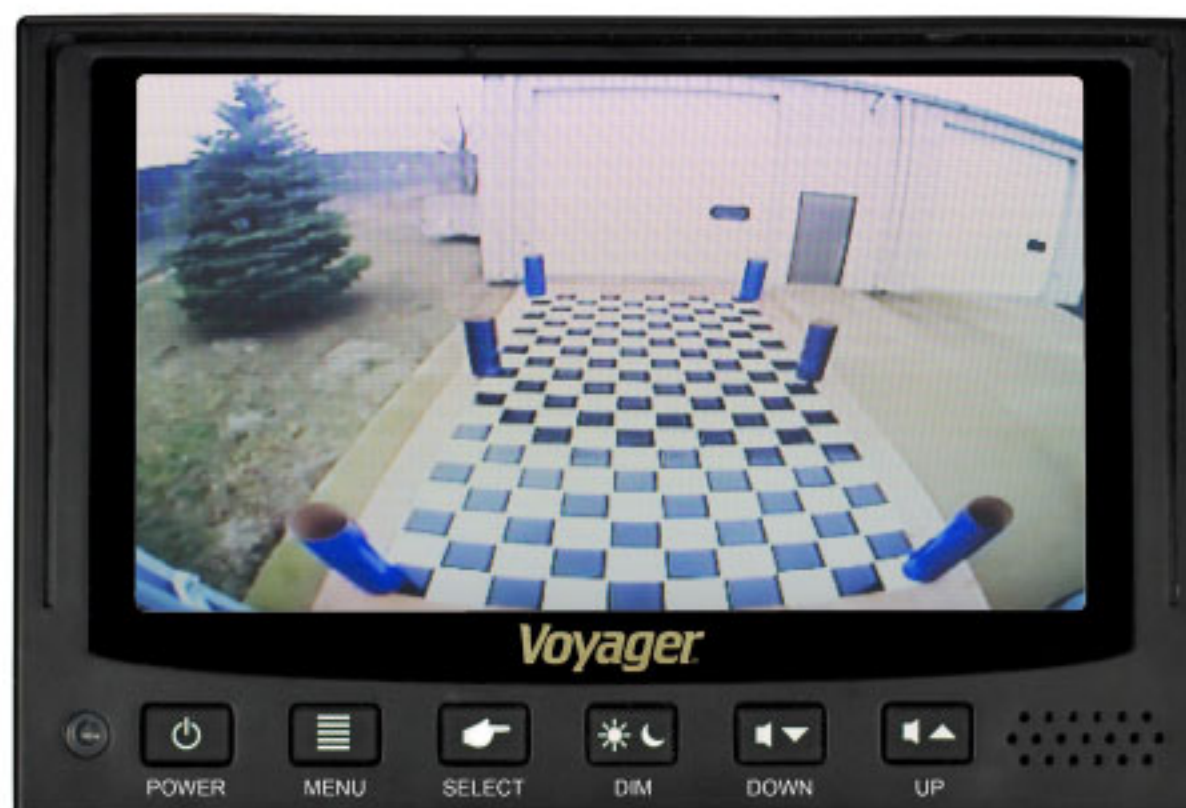
Vehicle Type: Cargo Van
Camera Height: 5.3'
Camera Used: VCMS155

Extended Side View Measurements

- 6.6' from first markers
- 15.6' from second markers
- 25.0' from third markers

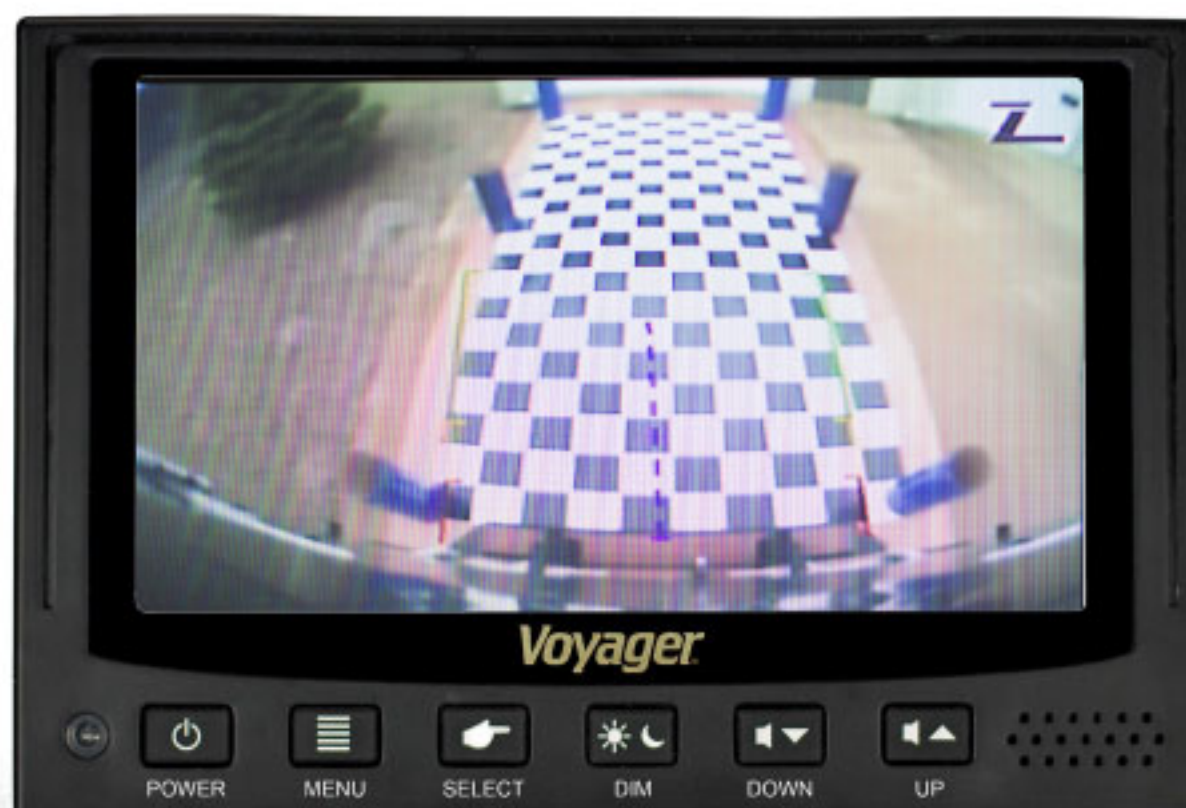
Vehicle Type: Walk-In Van
Camera Height: 9.5'
Camera Used: VCMS140i

Extended Side View Measurements

- 5.3' from first markers
- 16.6' from second markers
- 26.6' from third markers

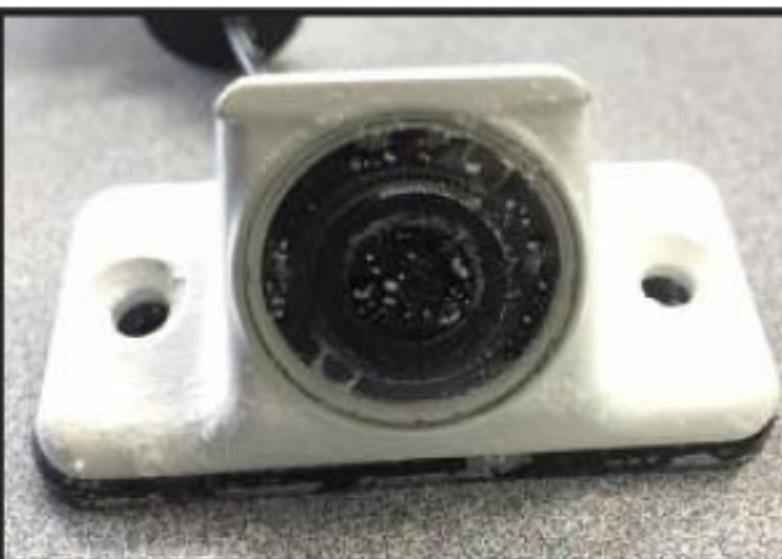
Camera	Test Observations	Results	
VCMS140i	Performed QFog Salt Fog Test on VCMS140i. After 24 hours examined the camera for signs of rust or corrosion due to the testing. Camera showed no signs of rust at 24 hours.	Pass

Corrosion Testing - QUV Salt/Fog Cyclical Corrosion Chamber

Voyager products are subjected to accelerated UV exposure that equates to 5-7 years of actual outdoor exposure to assure you that your electronics will function properly for many years. In addition, product and product components are subjected to dry/wet cycles of highly corrosive fog/mist to test for corrosion resistance and corrosion protection effectiveness.

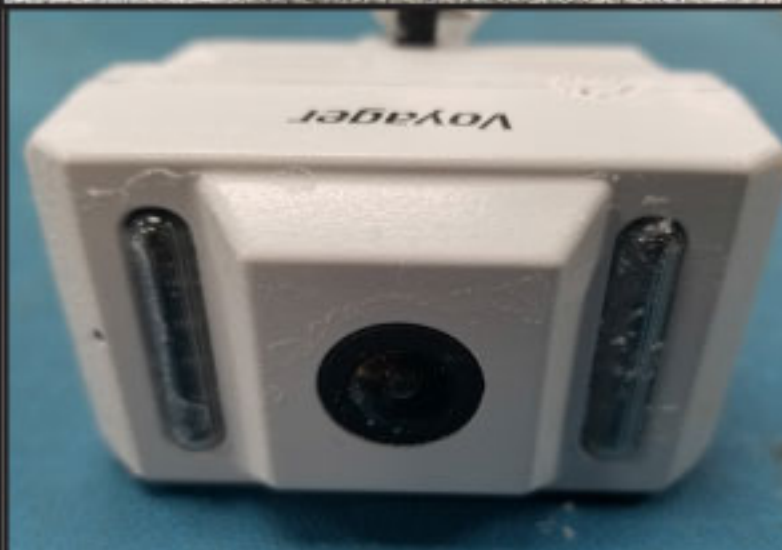
VCMS155	Performed QFog Salt Fog Test on VCMS155. After 24 hours examined the camera for signs of rust or corrosion due to the testing. Camera showed no signs of rust at 24 hours.	Pass

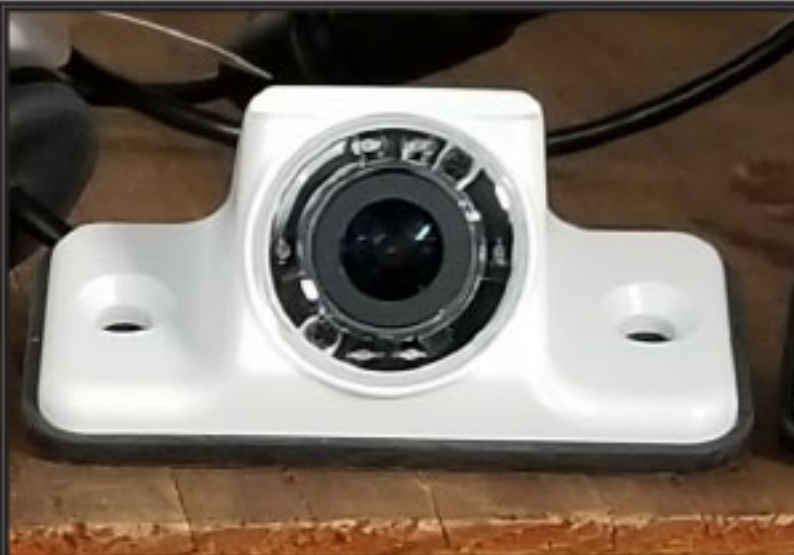
Camera	Test Observations	Results	
VCMS140i	Camera was set up in chamber at FMVSS 111 specifications as listed above. Camera was observed during testing and was fully functional throughout the test. Upon test completion, camera remained fully functional.	Pass

Humidity Exposure Testing - SES RK/20S Temperature/Humidity Chamber

Voyager products are subjected to long durations of 95% Relative Humidity at high temperatures to ensure the effectiveness of the conformal coating circuit corrosion protection. In addition to high humidity, products will also be exposed to rapid temperature cycles.

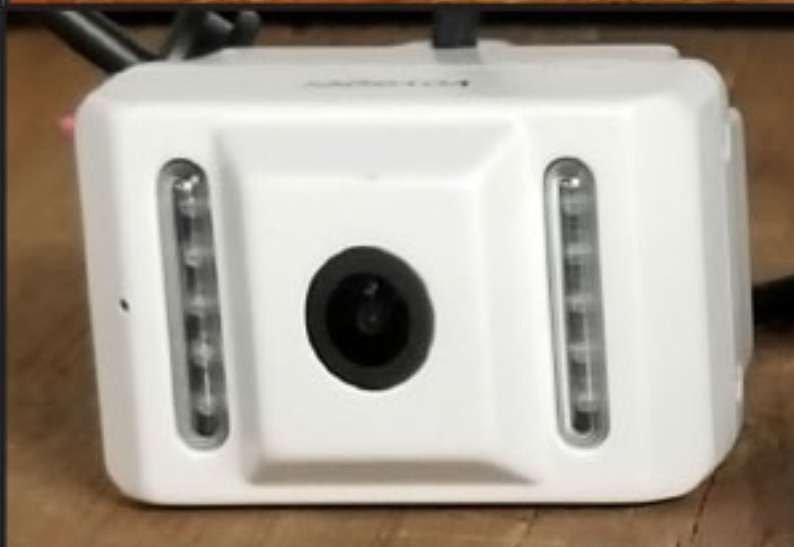
VCMS155	Camera was set up in chamber at FMVSS 111 specifications as listed above. Camera was observed during testing and was fully functional throughout the test. Upon test completion, camera remained fully functional.	Pass

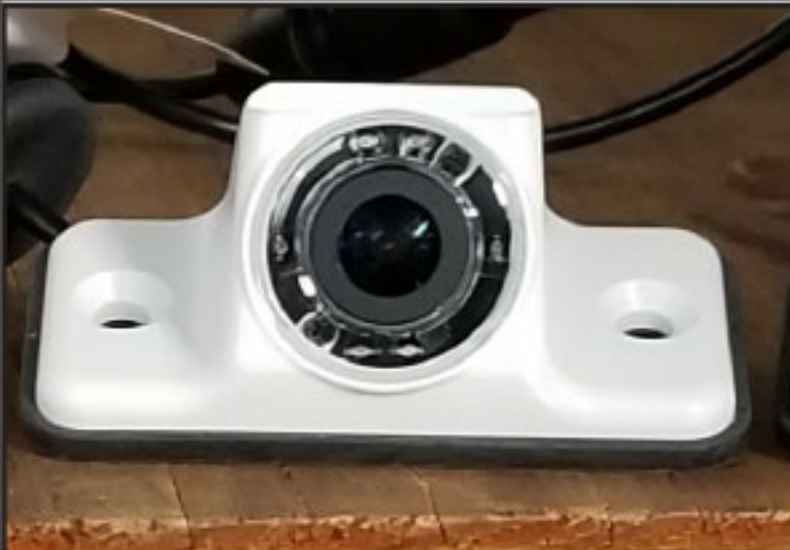
Camera	Test Observations	Results	
VCMS140i	Camera was placed in temperature chamber according to FMVSS 111 standards. camera was operational during test and monitored throughout. No abnormalities were noted and following test completion camera remained fully functional.	Pass

Temperature Exposure Testing - SES RK/20S Temperature/Humidity Chamber

Voyager products are subjected to long durations of exposure to operational temperature extremes, and rapid temperature cycles to ensure the highest level of reliability under the most severe temperatures and conditions our products may encounter.
